**Shipping Information Notice – 101**

**Cayman Island  
FLYER TO THE YACHTING INDUSTRY (05/2023)**

**Failure of “Side Boarding Ladders” attached to yacht hulls.**

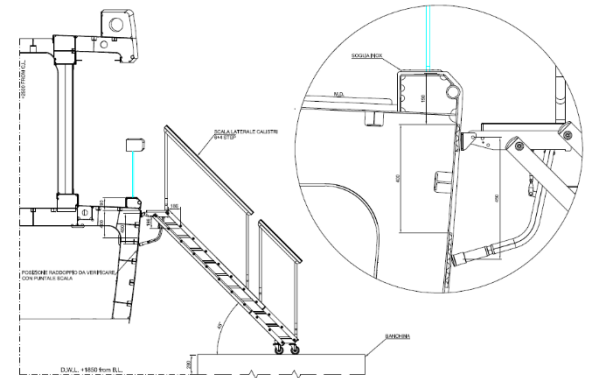
The Cayman Islands Shipping Registry (CISR) recently became aware of the failure of a side boarding ladder attached to the hull of a yacht. One crew member was using the side boarding ladder at the time of the failure. This crew member fell from the ladder into the dock and managed to escape serious injury.

A review of CCTV footage of the incident shows the crew member was extremely fortunate and could easily have sustained life changing or fatal injuries in the incident. The incident was not reported to CISR or the Maritime Authority at the time of occurrence.

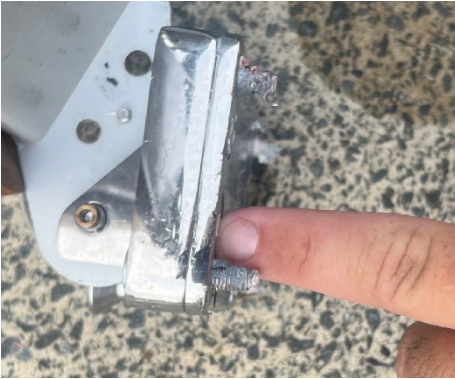
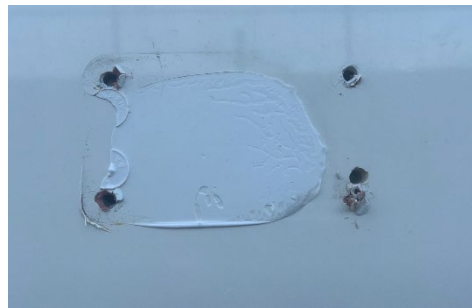
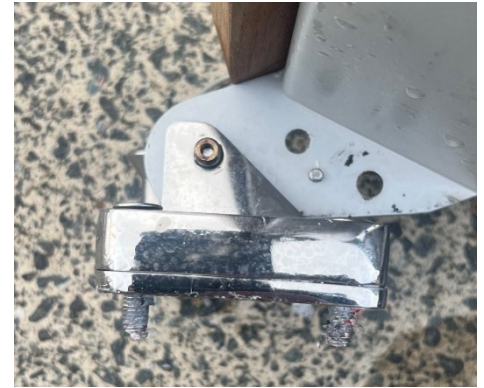
Photographs:

The bolts securing the mounting bracket of the side boarding ladder only extended approximately 15mm from the bracket and did not engage with any doubling plate that may have been fitted;

The mounting bolts were only “engaged” in the fairing compound and pulled out of the fairing compound during the incident;

The threads of the mounting bolts were not “stripped” during the pull out; and

The side boarding ladder did not comply with the REG Yacht Code with respect to intermediate rails or wires. See Safety Flyer “[Incidents on Gangways, Pasarellas and Accommodation Ladders](#)”.

Such side boarding ladders should be REMOVED FROM SERVICE until –

all parts of the side boarding ladder (including and “hardware” and fittings) have been visually examined for defects by a competent person; and

a competent person is satisfied that all attachment arrangements to the yacht's hull are fit for the intended purpose. This should include the removal of any screwed attachment to ensure that attachment hardware is of sufficient size and strength that properly and securely attaches the side boarding ladder to the hull.

It is recommended that side boarding ladders are subject to the same examination and load testing regime as pasarells and other gangways. All load tests, including post-installation tests, should be witnessed by the vessels Class Society.
